ENEWETAK FACT BOOK

(A RESUMÉ OF PRE-CLEANUP INFORMATION)

COMPILED BY
WAYNE BLISS
U.S. ENVIRONMENTAL PROTECTION AGENCY

COMPILED 1977
PUBLISHED SEPTEMBER 1982

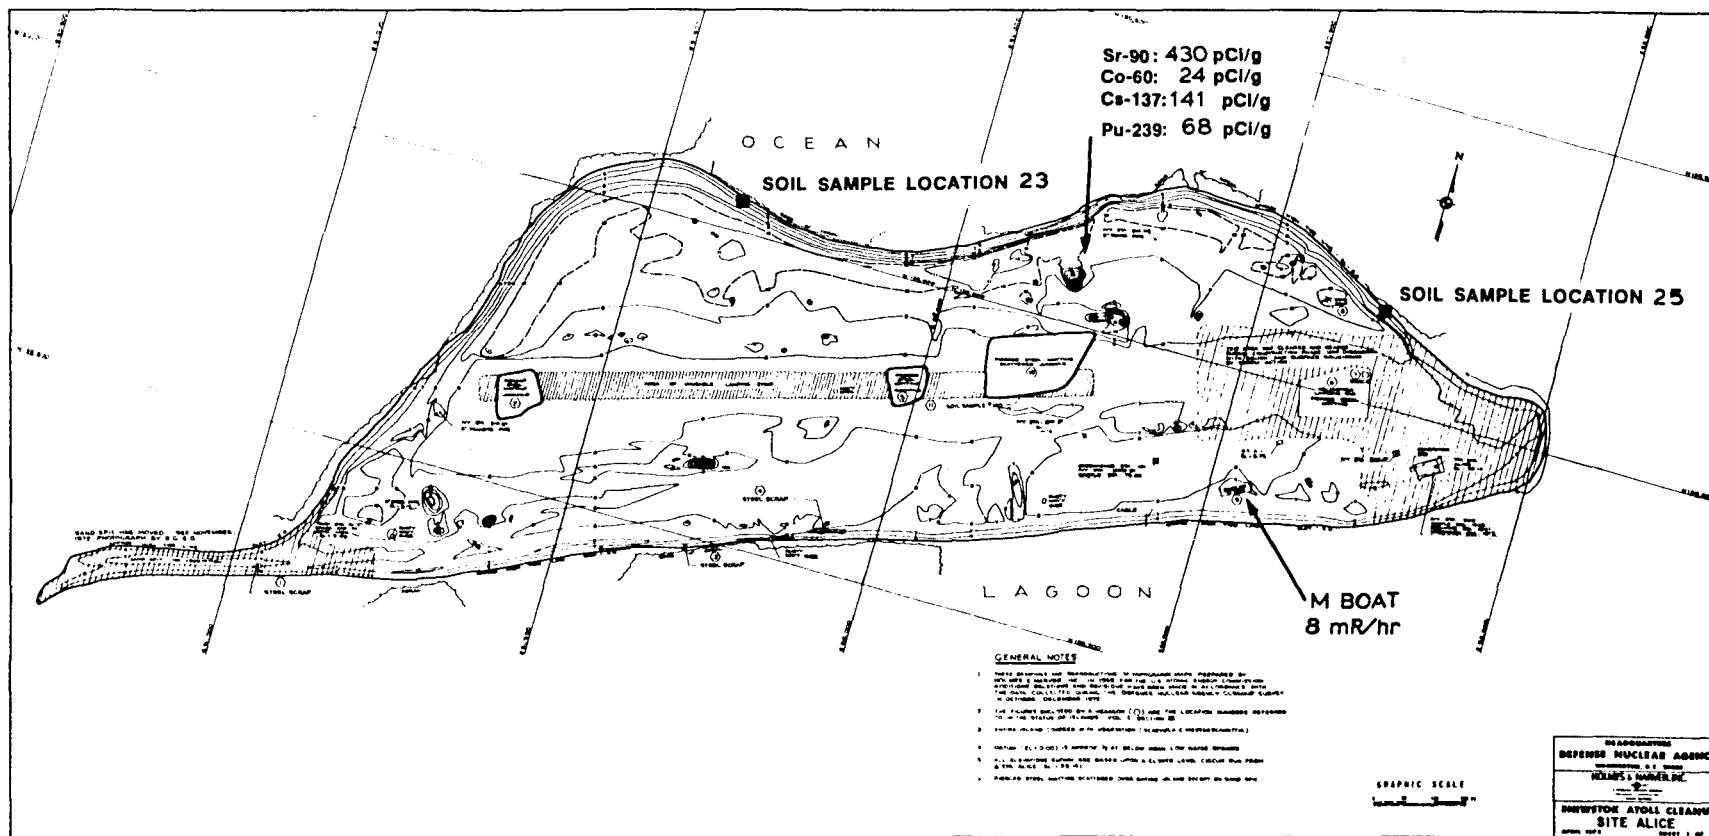
FIGURE 2. SITE ALICE

Soil sampling locations 23 and 25 (See Figure 2) near the northern edge of the island do not show a decrease with depth to the maximum sampled depth of 30 cm. This is likely a result of earth moving activities in the area of location 25 and wave disturbances in both. The ²³⁹Pu level was less than 10 pCi/g from the surface to 30 cm in each case.

There are no known burials of radiocontaminated materials on ALICE. Scrap material on the island has been inconclusively classified as uncontaminated within the background levels of the island with the exception of a wrecked M-boat on the lagoon beach near the east end of the island.

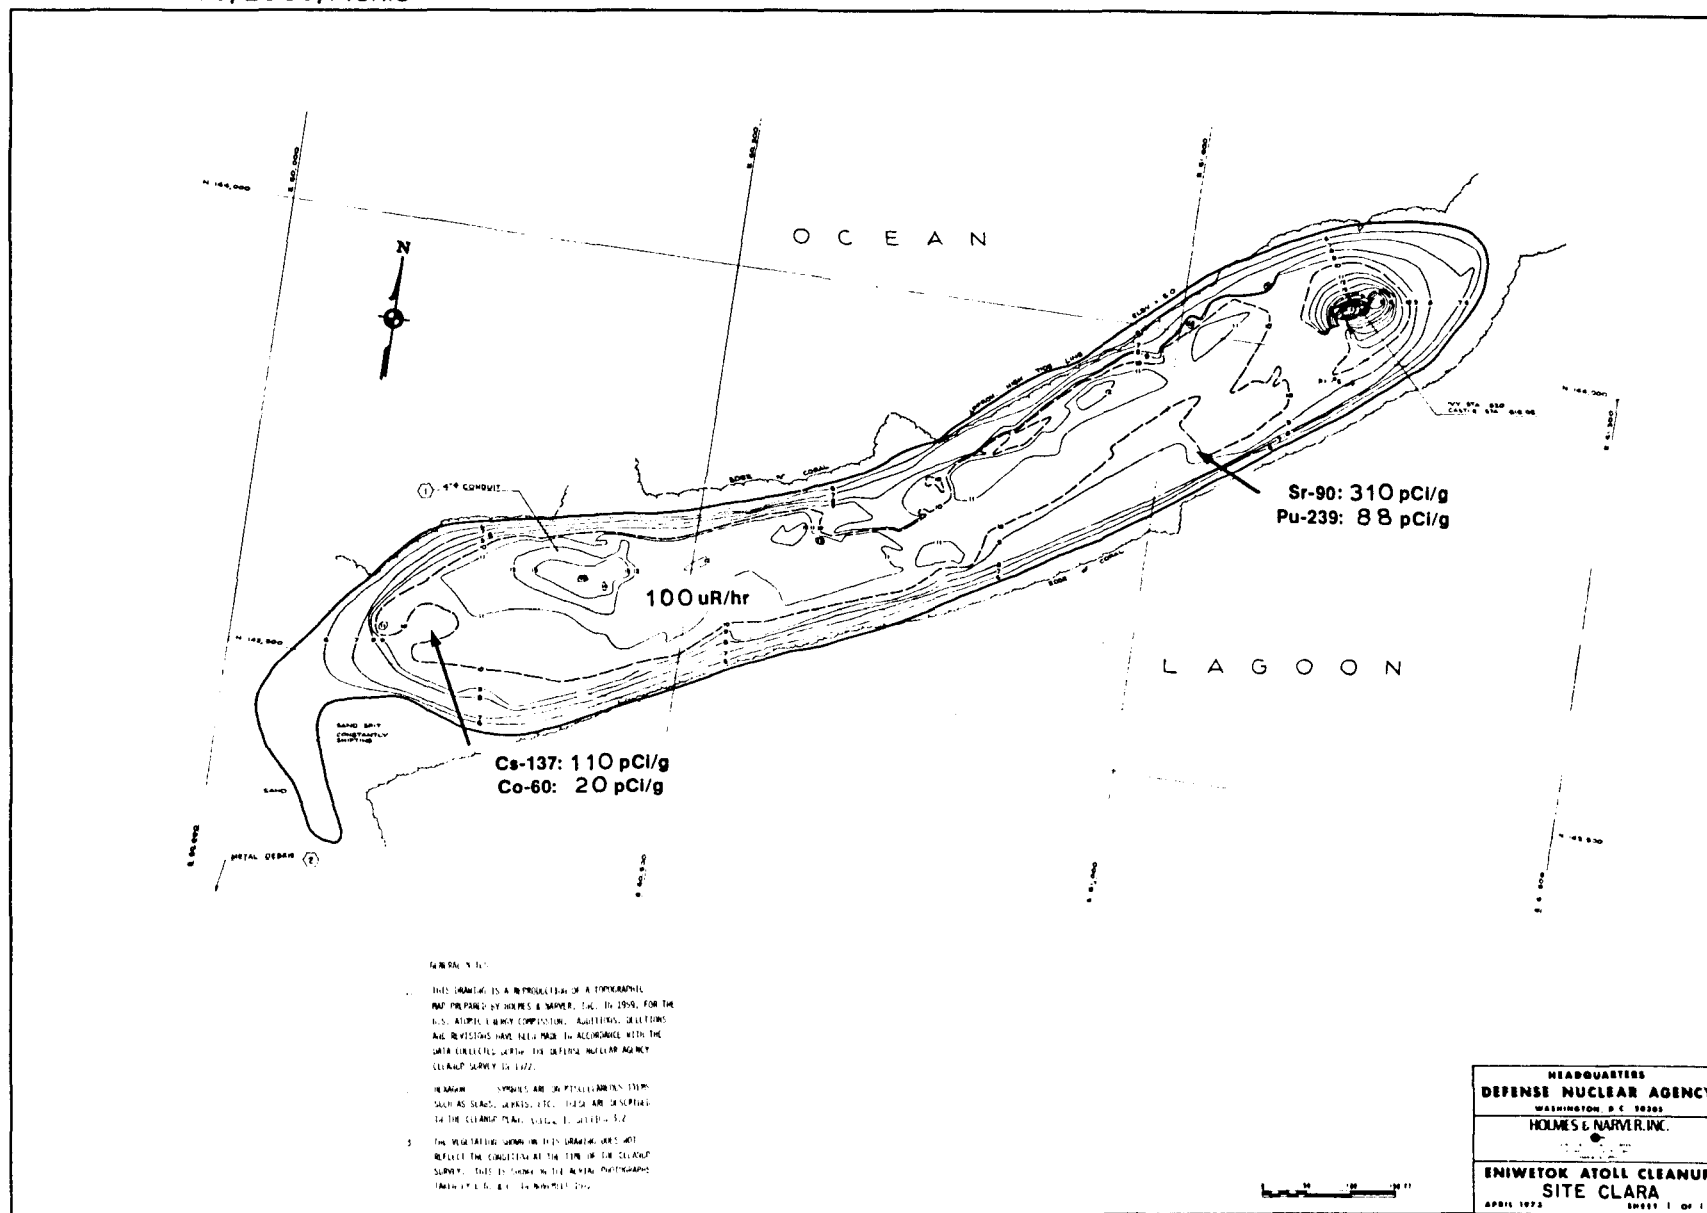
FIGURE 4. SITE CLARA

No known or suspected burial sites for radioactive materials exist on CLARA. The small quantity of scrap material to be found on CLARA is apparently not contaminated above the island background.

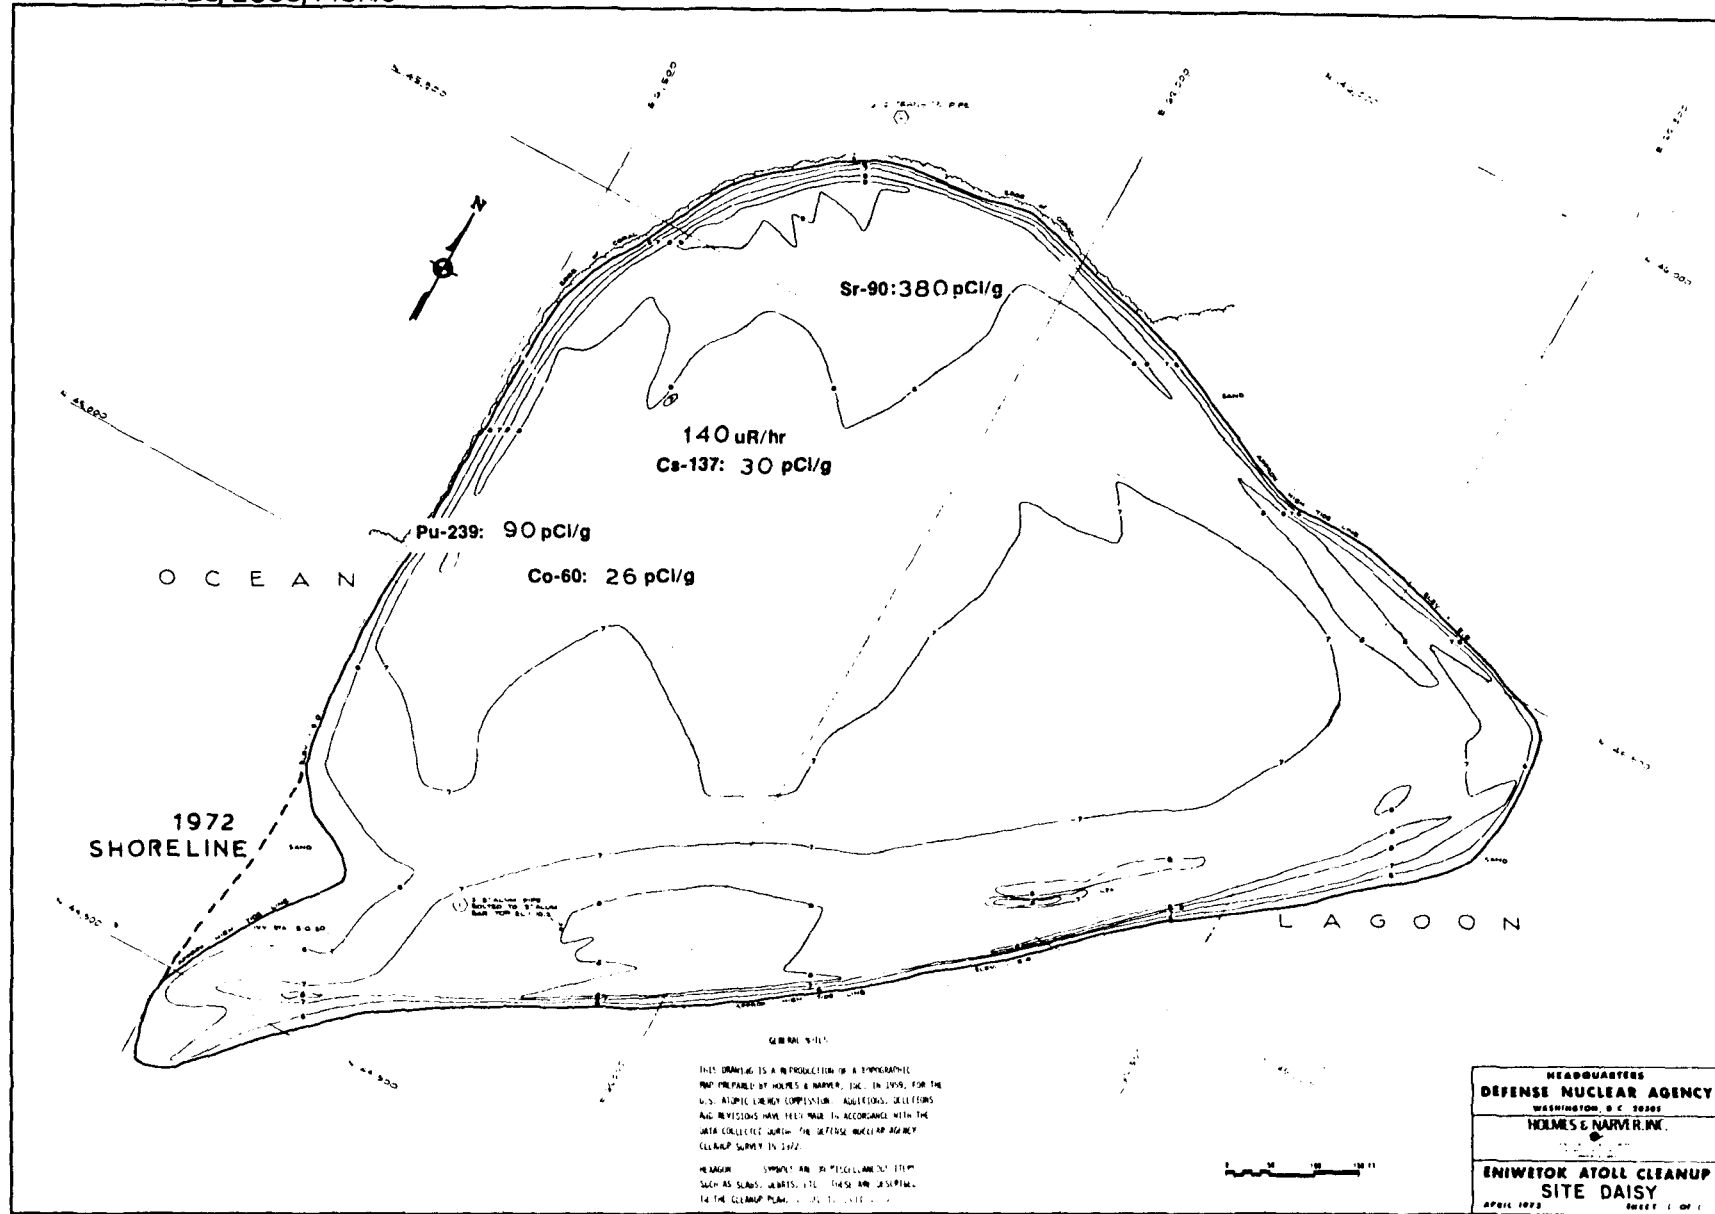
FIGURE 5. SITE DAISY

No known or suspected burials of radioactive materials exist on DAISY. The small amount of scrap material there is apparently not contaminated above the island background.

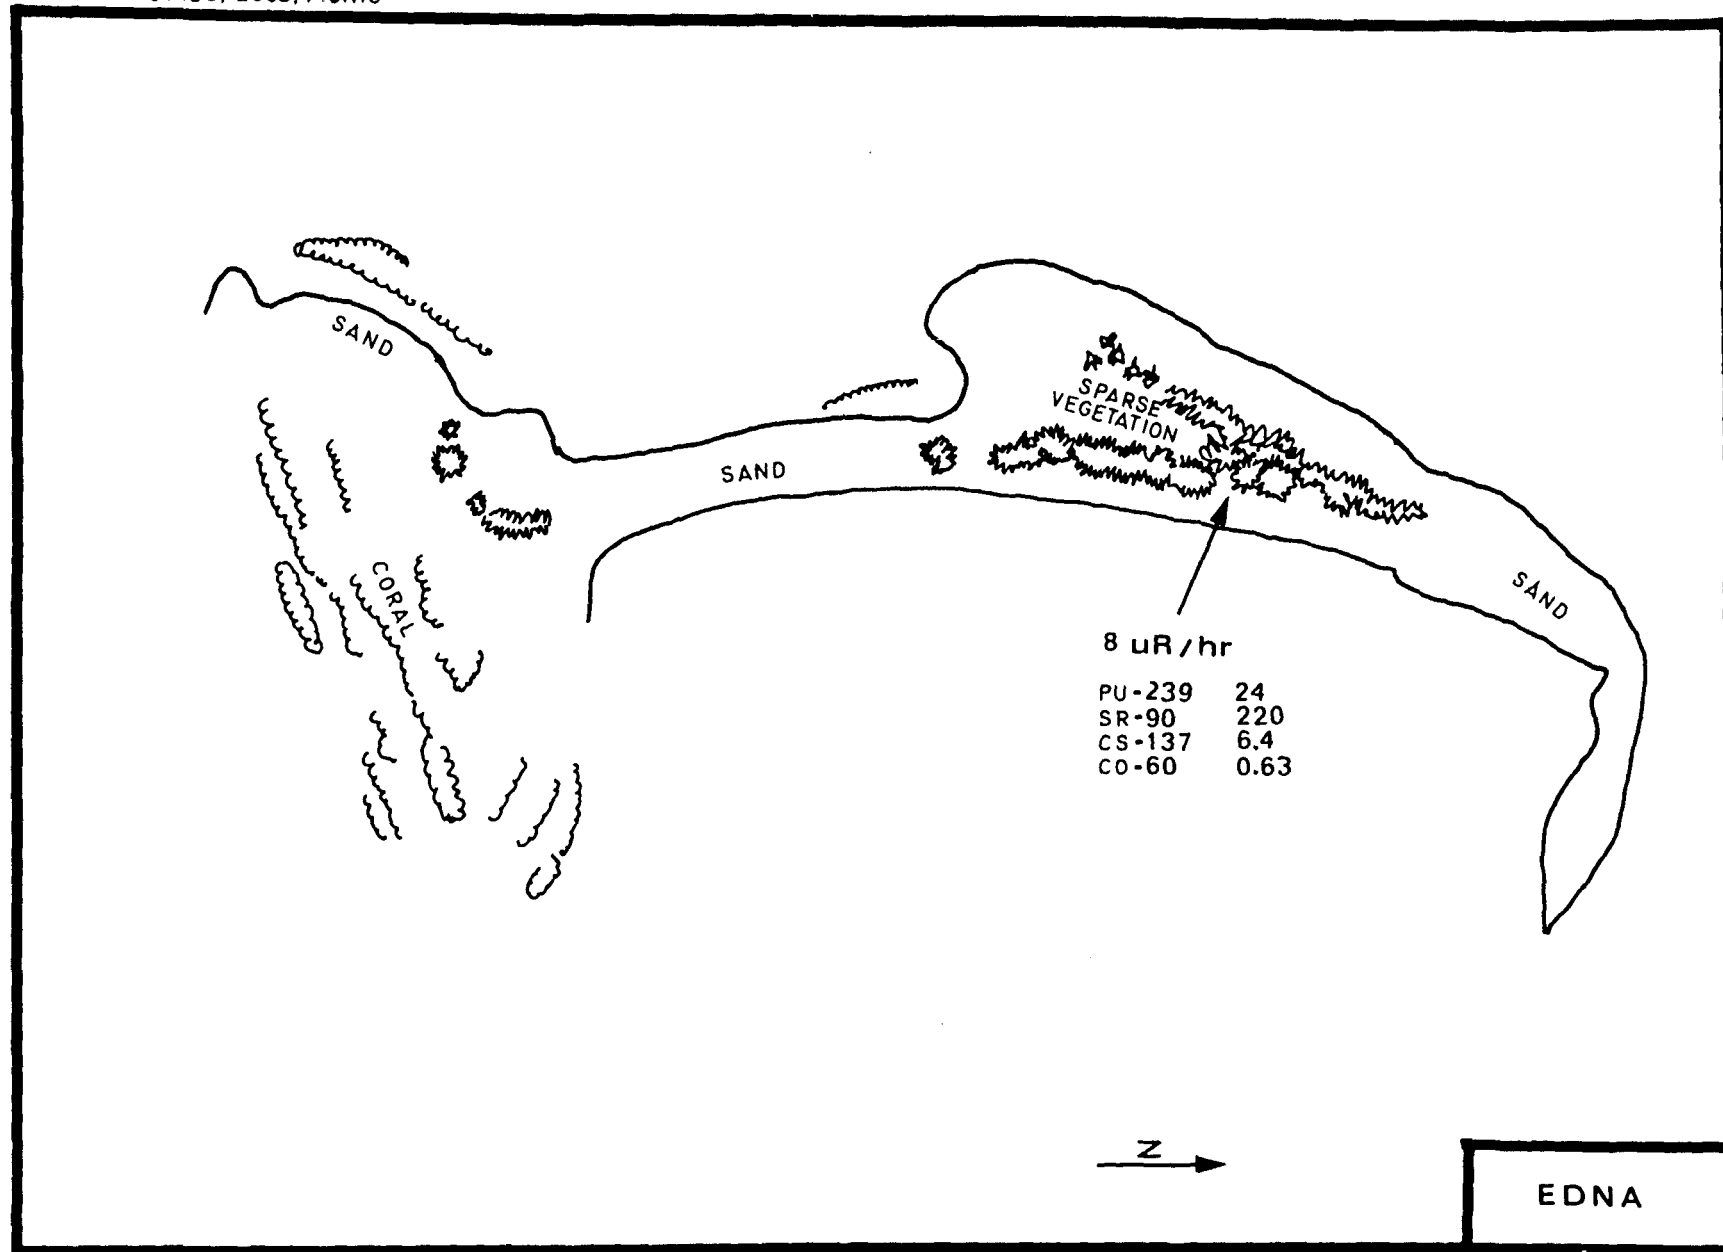
FIGURE 6. SITE EDNA

No burial sites, contaminated scrap or structures are known to exist on EDNA.

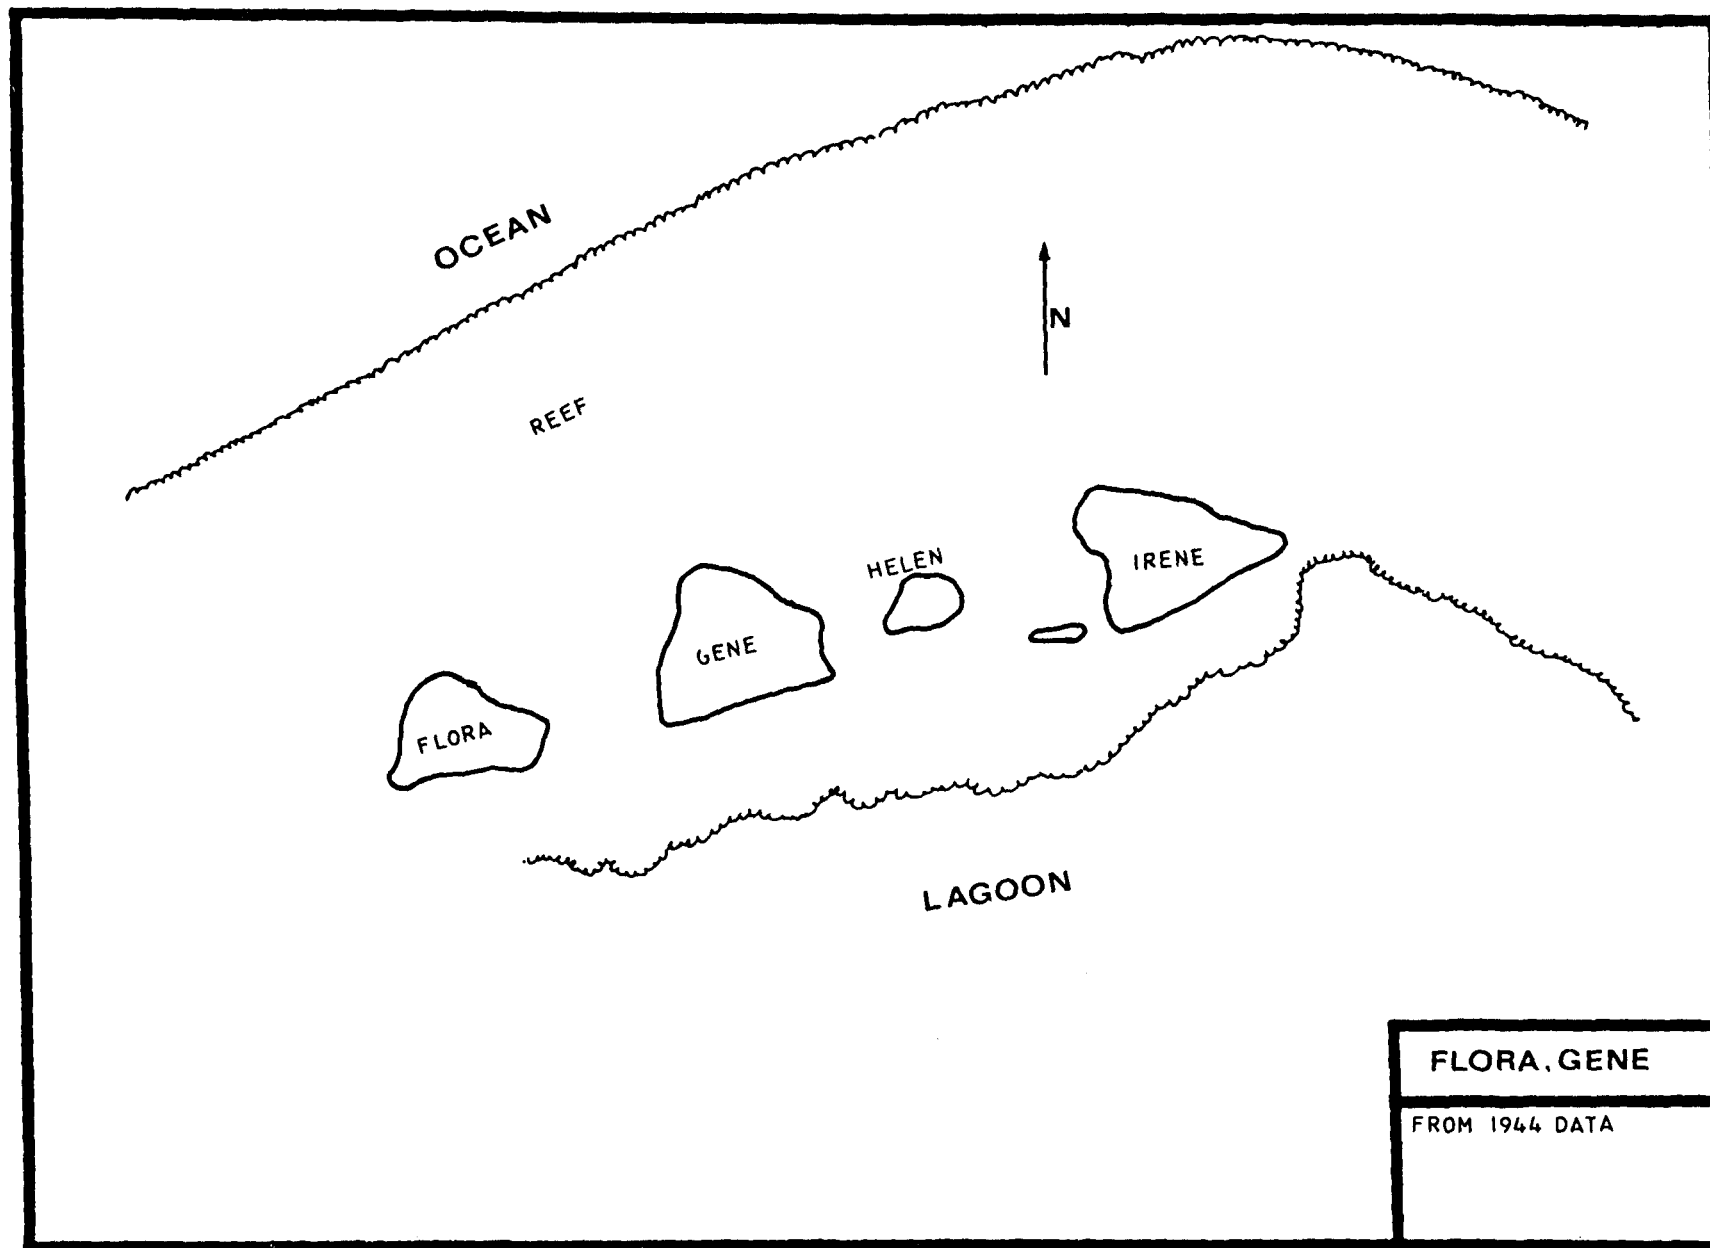
FIGURE 7. SITES WHERE FLORA, GENE AND HELEN FORMERLY WERE, RELATIVE TO SITE IRENE

Prior to OPERATION IVY, GENE through IRENE were four islands in a linear arrangement at the north end of Enewetak Atoll. During nuclear test operations these islands were connected by various systems of causeways, pipelines and cables. Figure 7 shows their original configuration.

FLORA was the site of the MIKE EVENT of OPERATION IVY. MIKE was an experimental thermonuclear device detonated October 31, 1952, which yielded 10.4 megatons. MIKE cast FLORA to the winds; however, her location was to be used for many succeeding barge shots.

GENE, the site of one forward area camp, served as a work area through OPERATIONS CASTLE and REDWING. As a result of the KOA EVENT, May 12, 1958, of OPERATION HARDTACK, PHASE I, GENE followed FLORA into oblivion. No radiological measurements have been made of these two areas in recent years. No estimate of cleanup, if any is warranted, has been made other than that incorporated with IRENE. Pipelines ran from IRENE to both MIKE and KOA and some of that debris may remain on the reef.

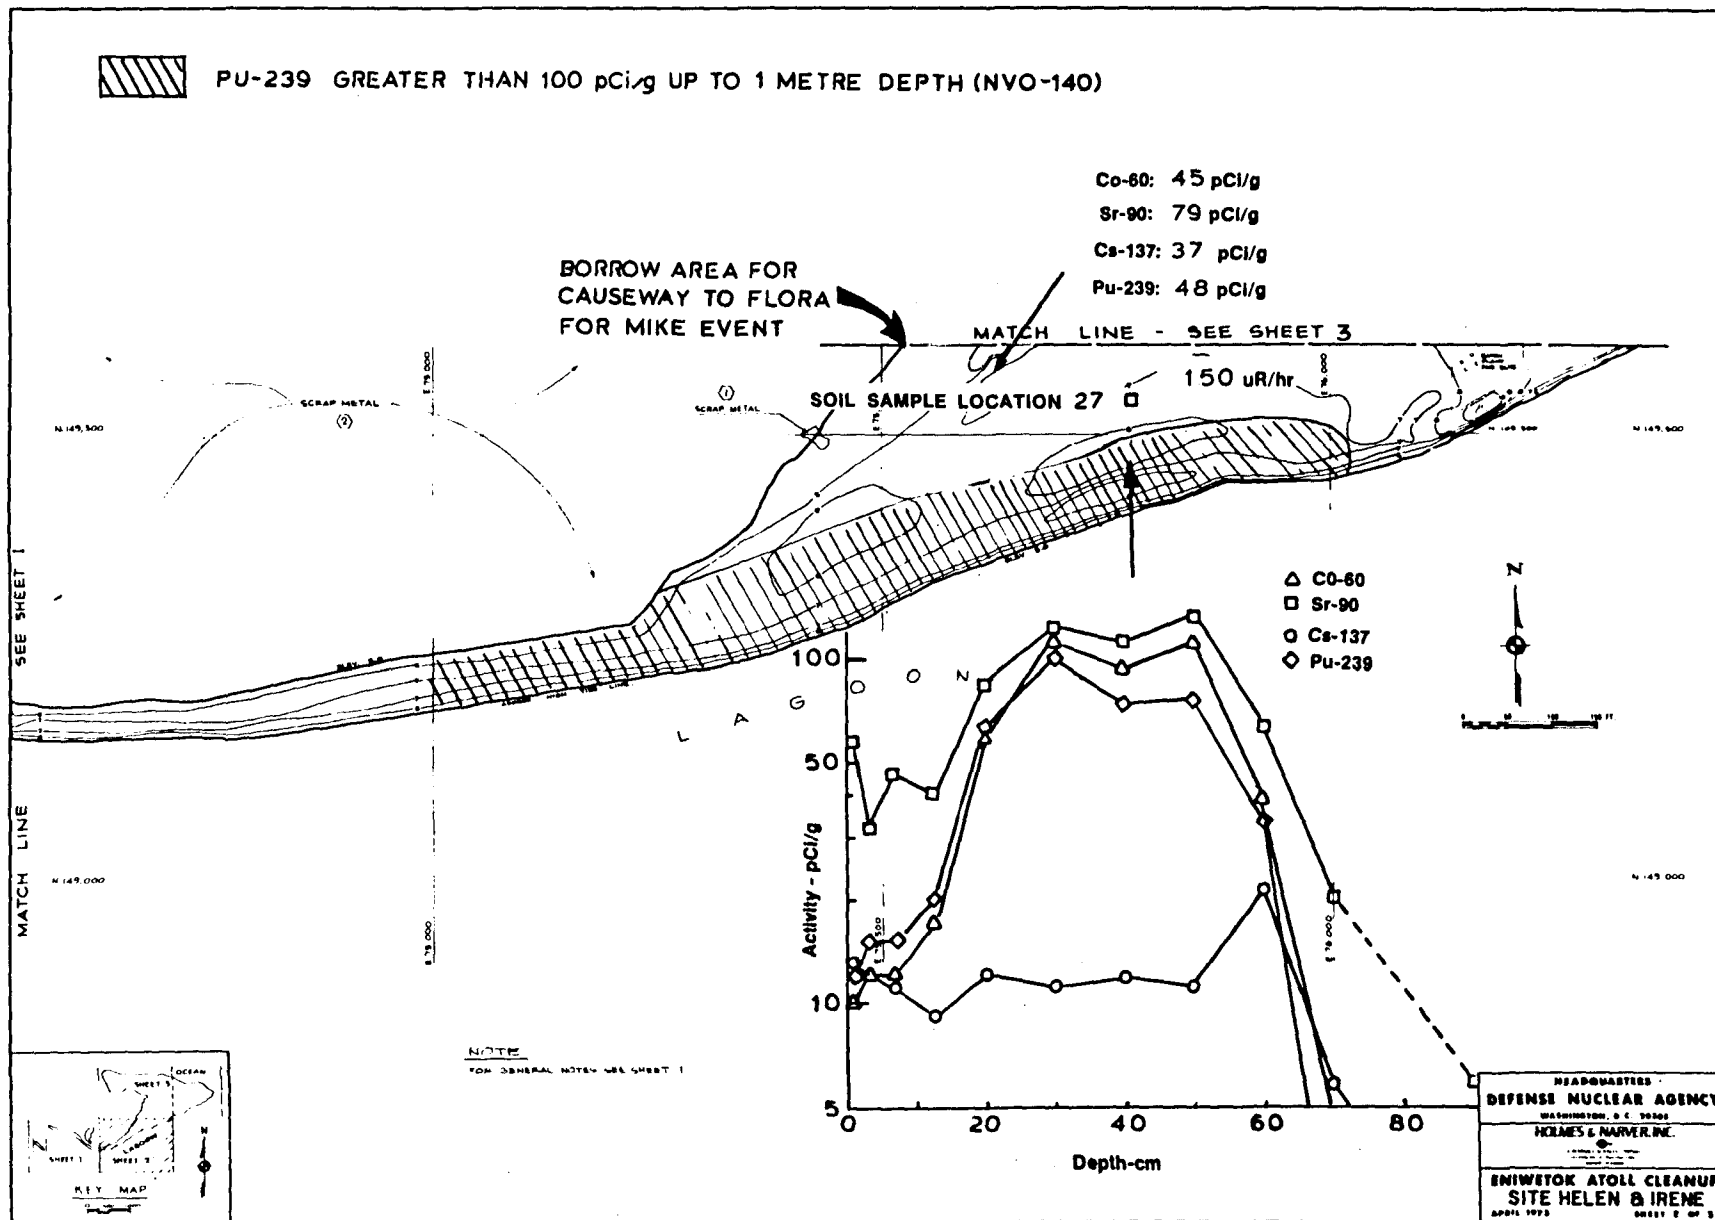
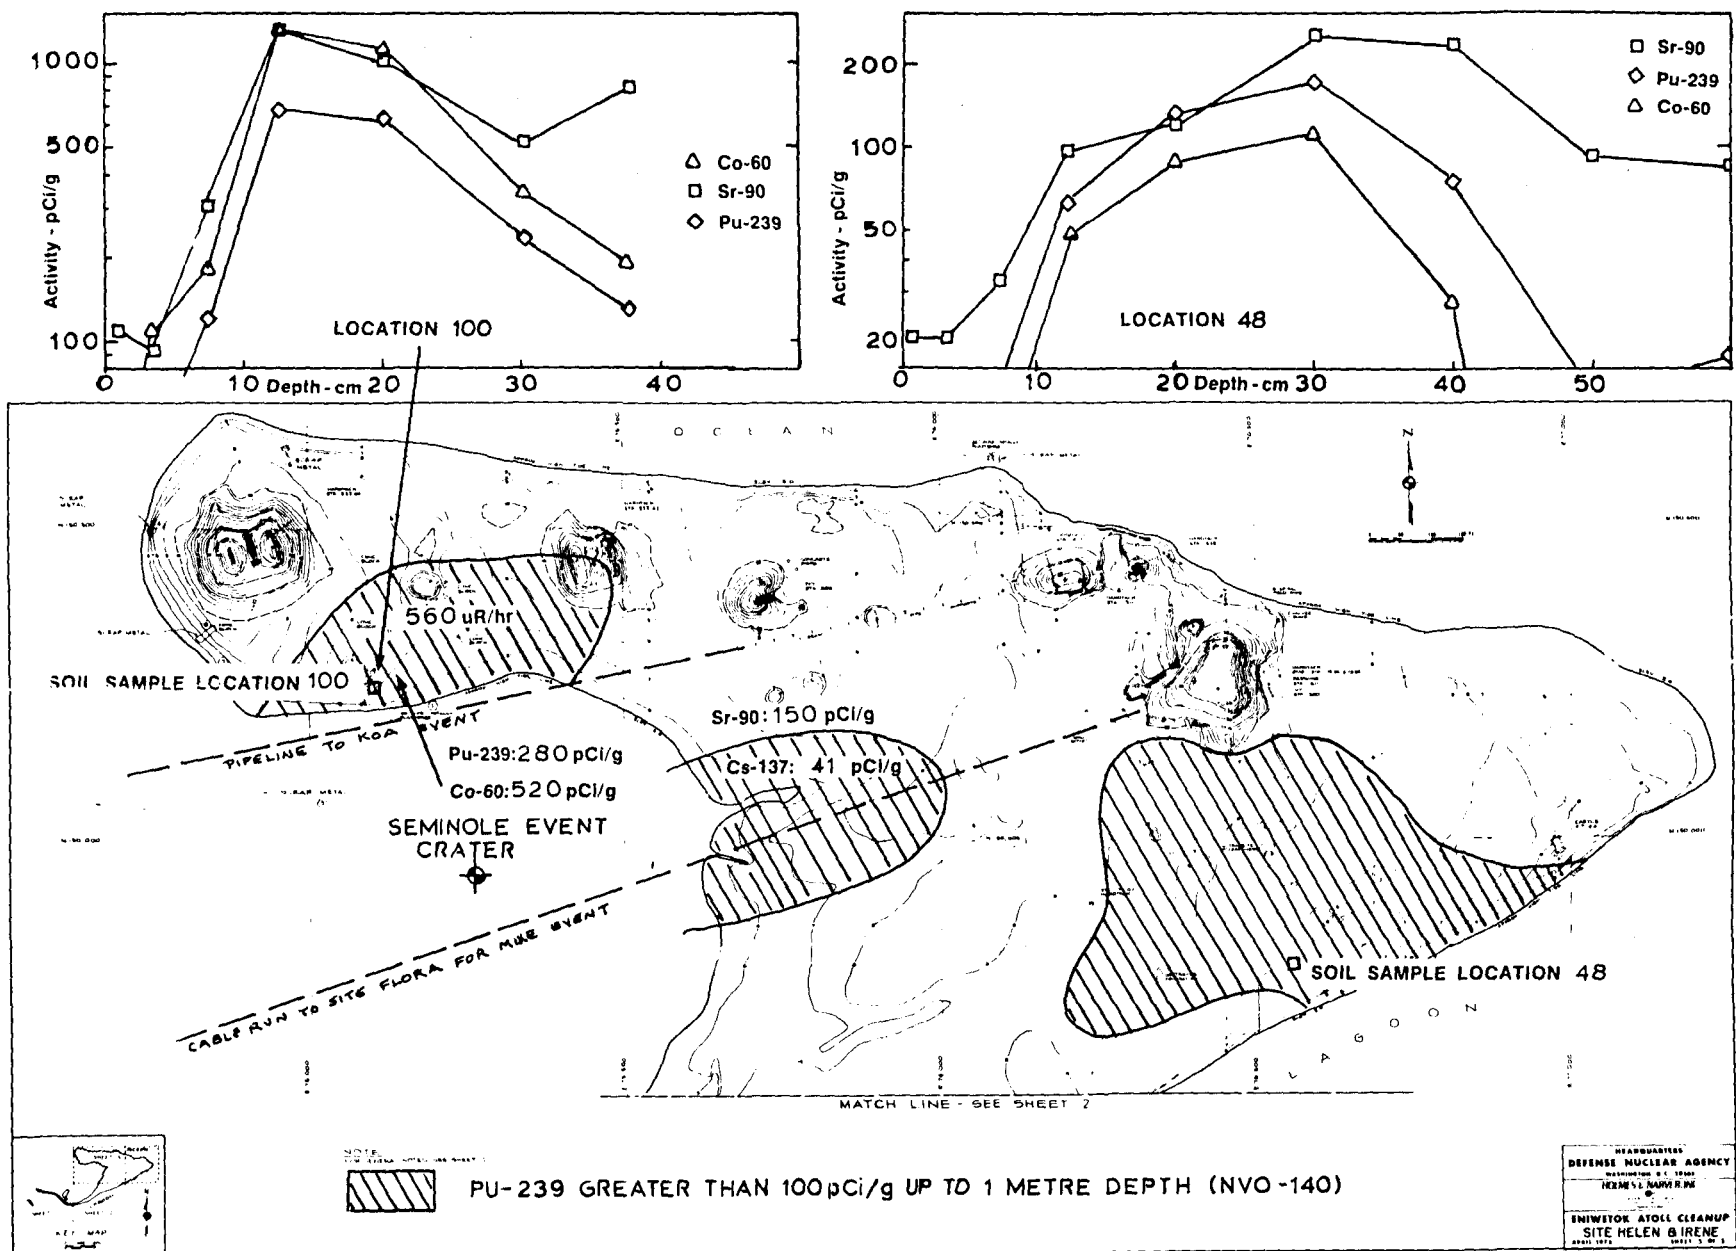
FIGURE 9. SITES HELEN AND IRENE, SHEET 2 OF 3

^{239}Pu activities of about 100 pCi/g to depths as much as one meter have been identified for several areas on the island. These areas are cross-hatched on Figures 9 and 10.

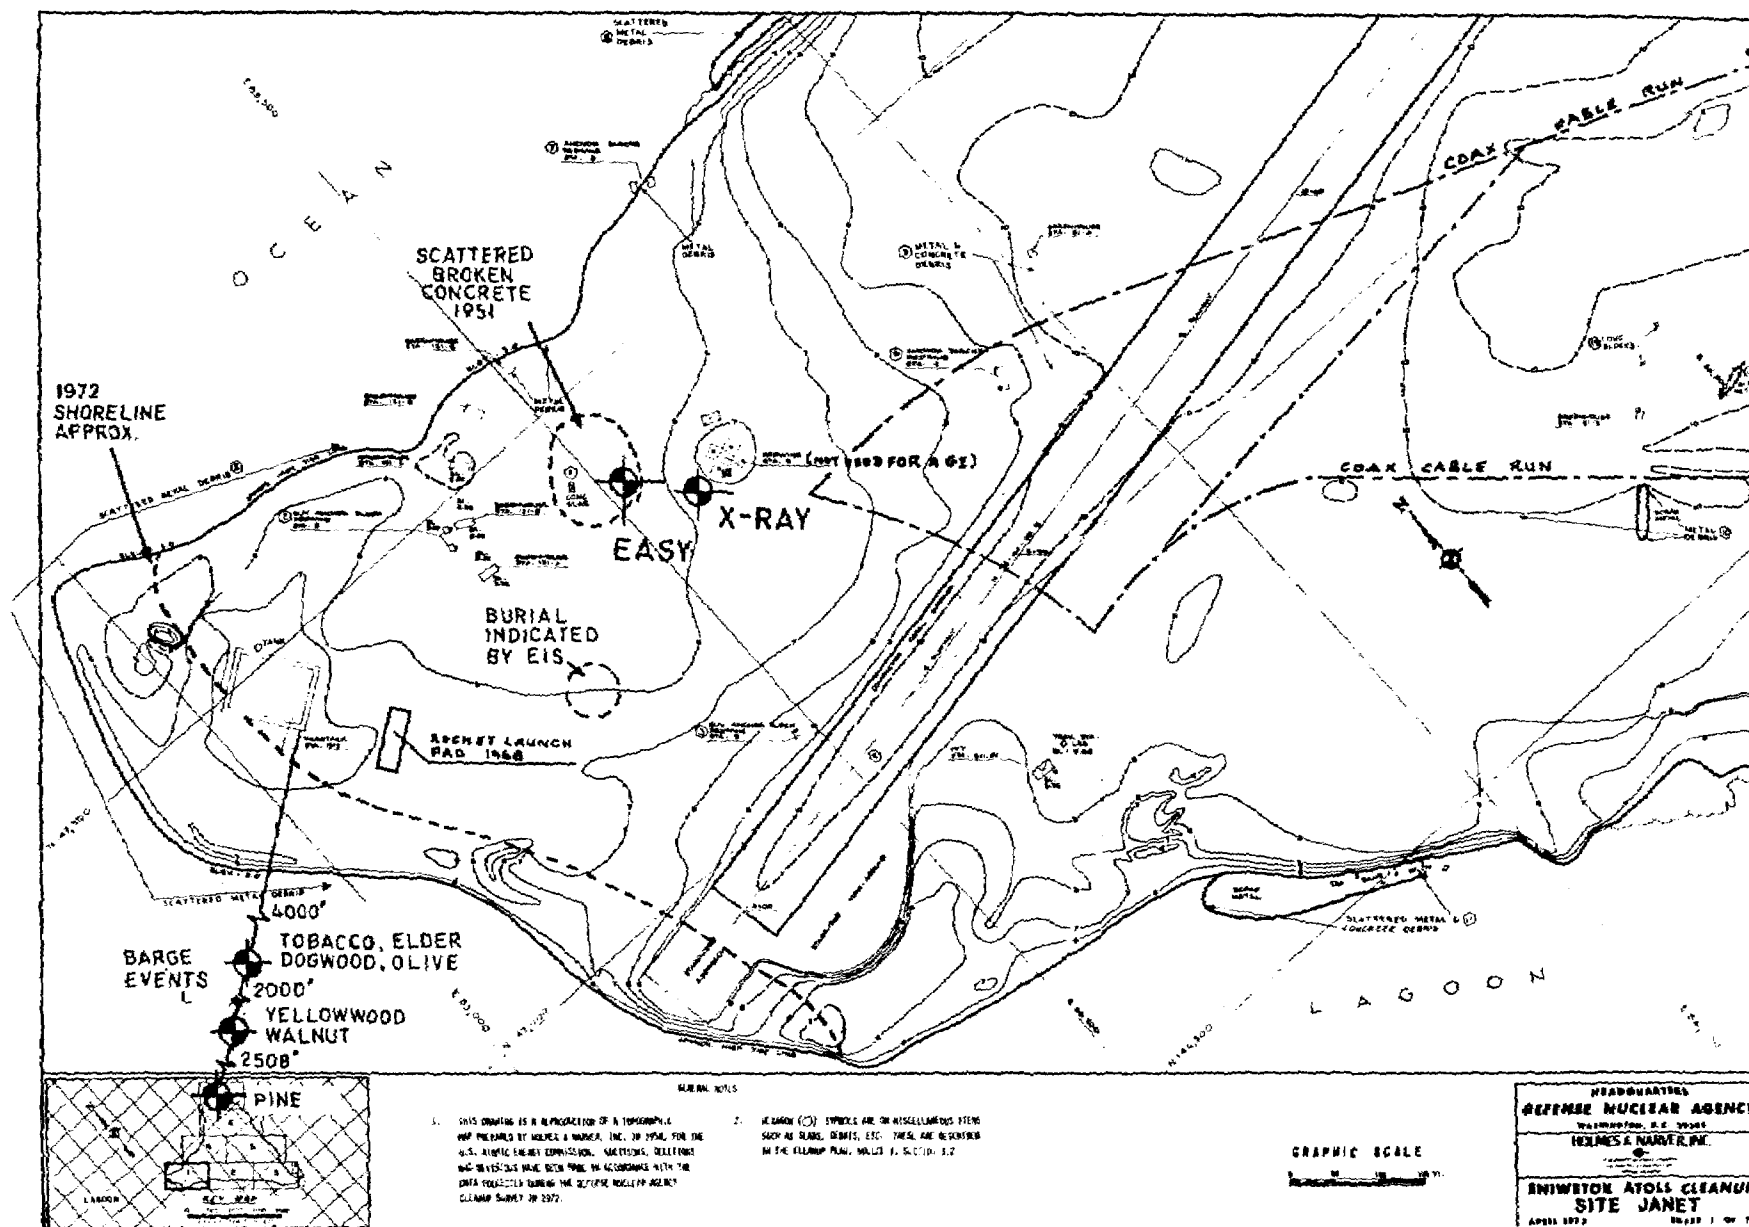
FIGURE 11. SITE JANET, SHEET 1 OF 7

The Environmental Impact Statement specifies two plutonium bearing "crypts" on JANET. These two areas are designated on Figures 11 and 17, one near X-RAY GZ and one near ITEM GZ. These are more likely land fill burials if they exist. No supportive evidence has been found.

STANDARD ASSUMPTION OF GZ BURIAL APPLIES

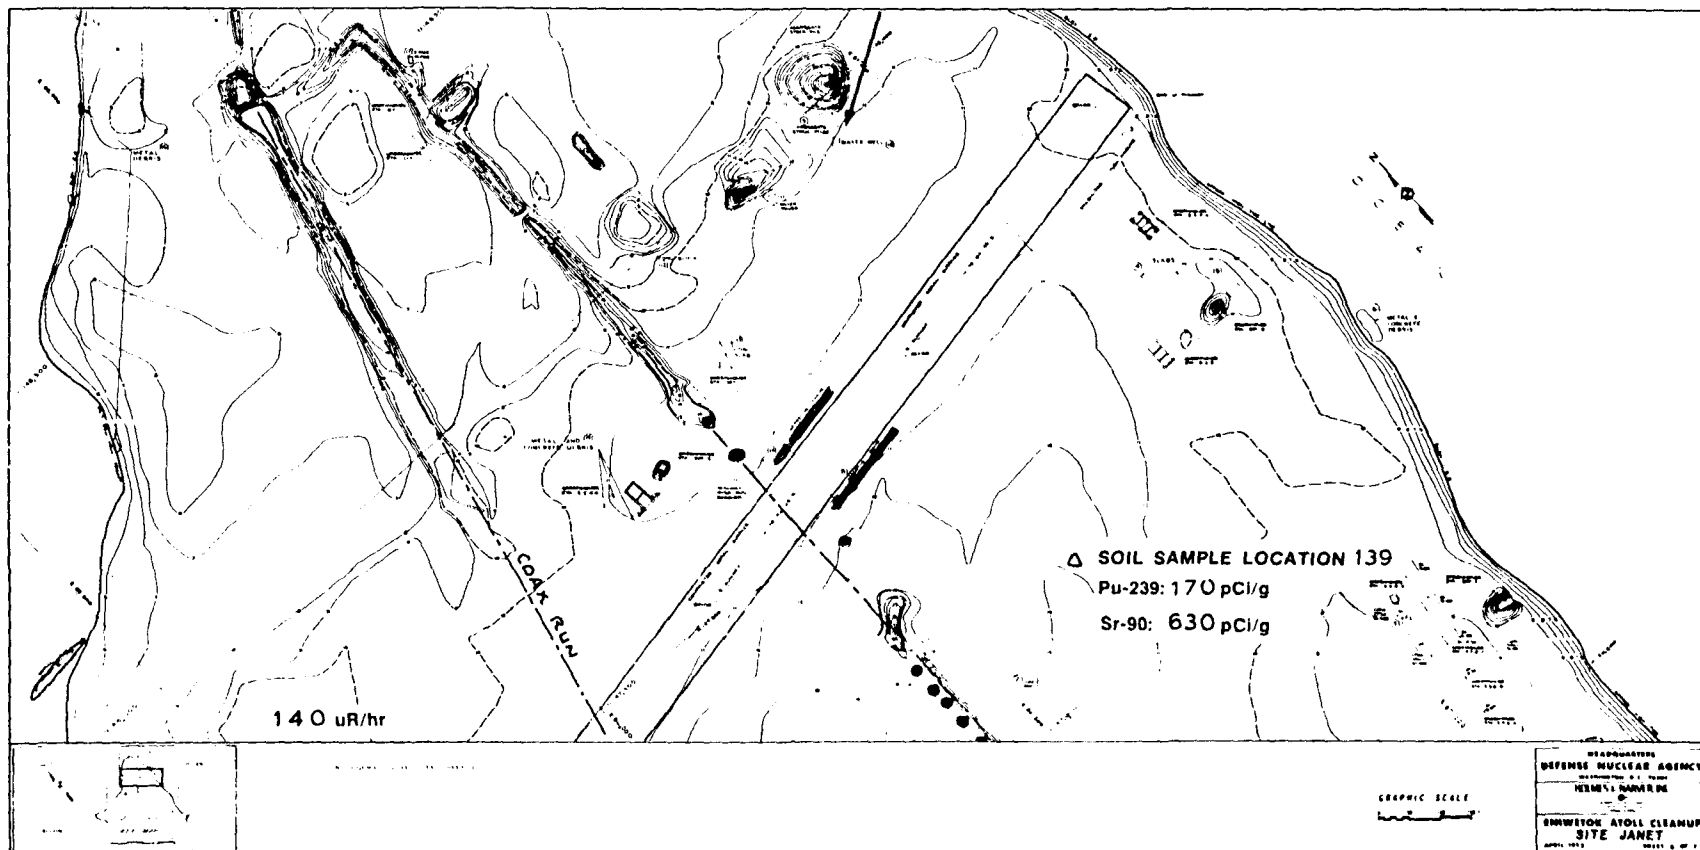
FIGURE 16. SITE JANET, SHEET 6 OF 7

Figure 16 shows a water well north of the runway near its east end. Cleanup calls for removing the contaminated above-ground structures from the well and plugging the 16-inch casing. This well should be reconsidered for future use as a sampling source or irrigation source. Also JANET has a well developed fresh water lens which should not be disturbed any more than necessary during cleanup. This lens could be an important future resource to the northern Atoll.

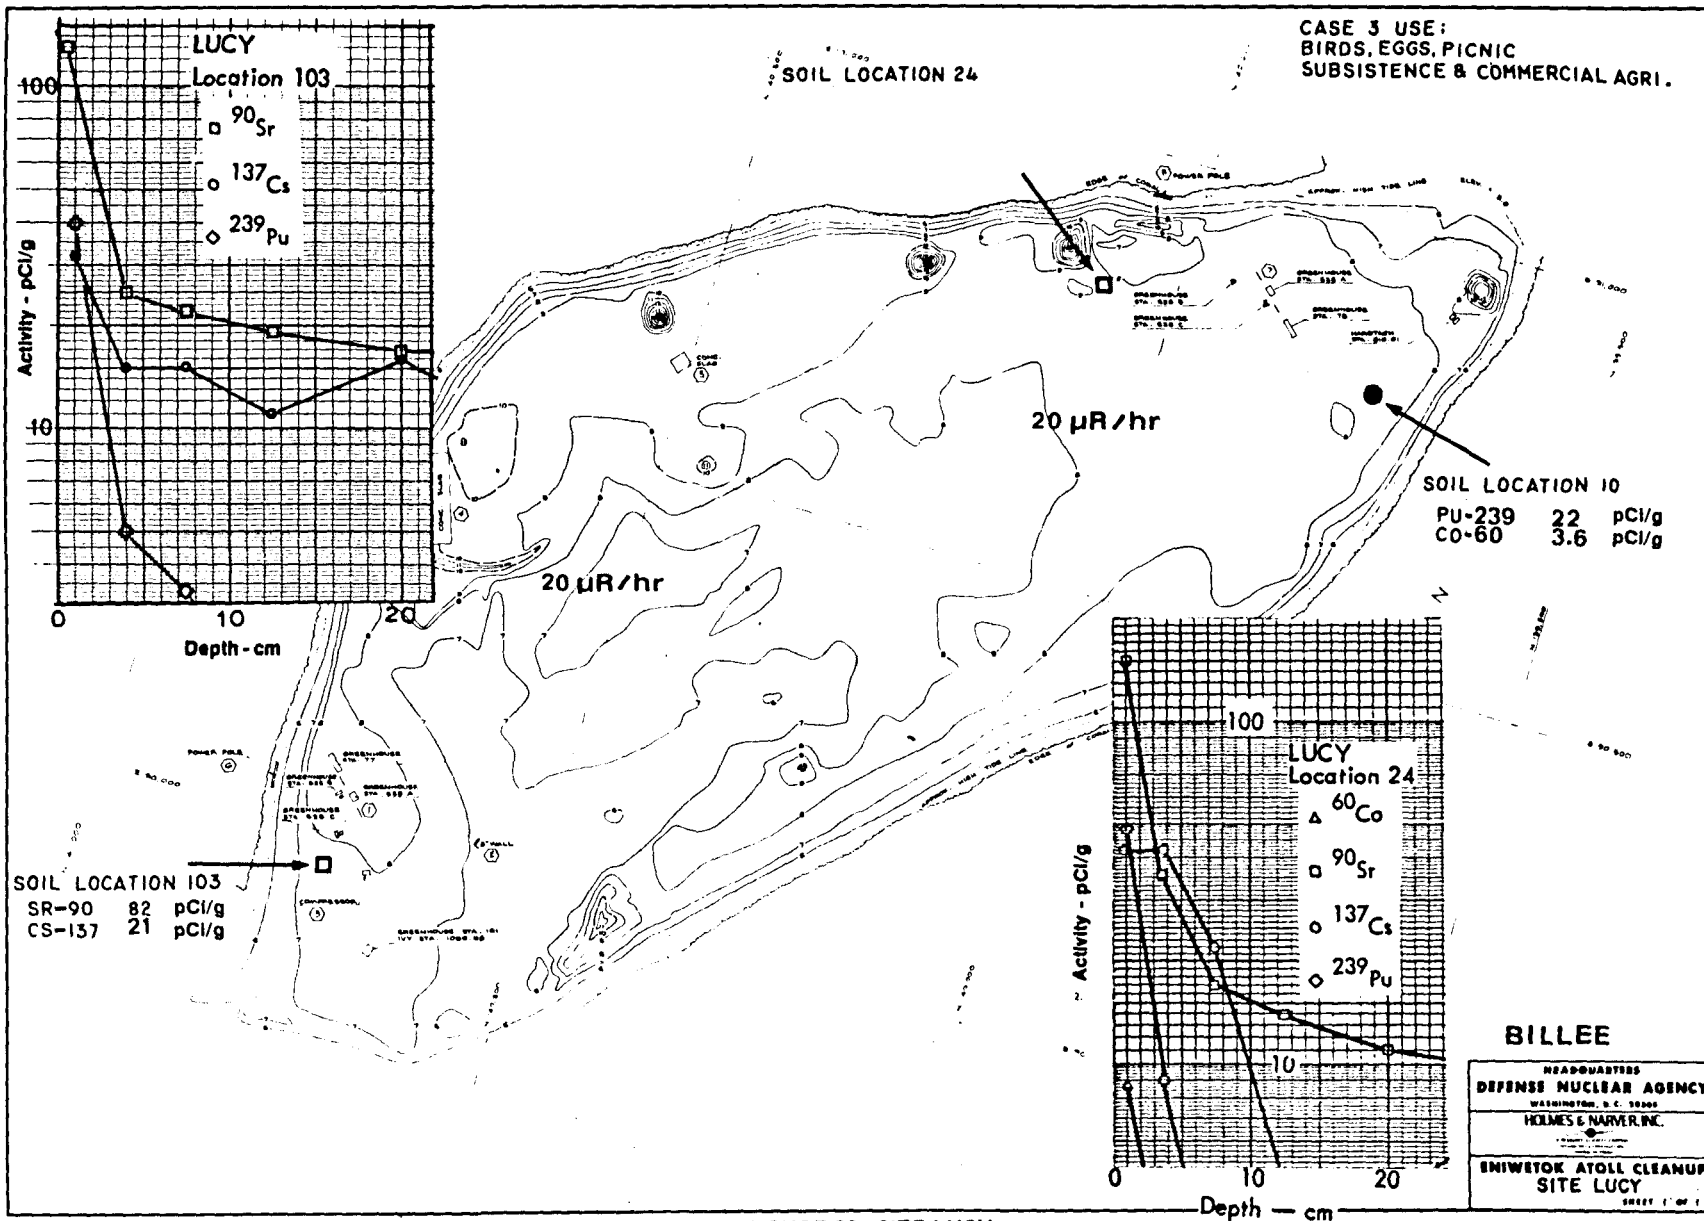
FIGURE 36. SITE LUCY

The profiles generally reflect a sharp decrease in activity in the top 10 cm (relaxation lengths of about 5 cm) and a leveling off below this depth (Figure 36). Because of the relatively small number of soil samples, the data was considered as a single population; however, the isoexposure contours developed from the aerial survey measurements reflect lower exposure rates over the less dense vegetation, i.e., the southeast end.

No radioactive material burial sites are known to exist on LUCY. Scrap and debris has not been classified as contaminated.

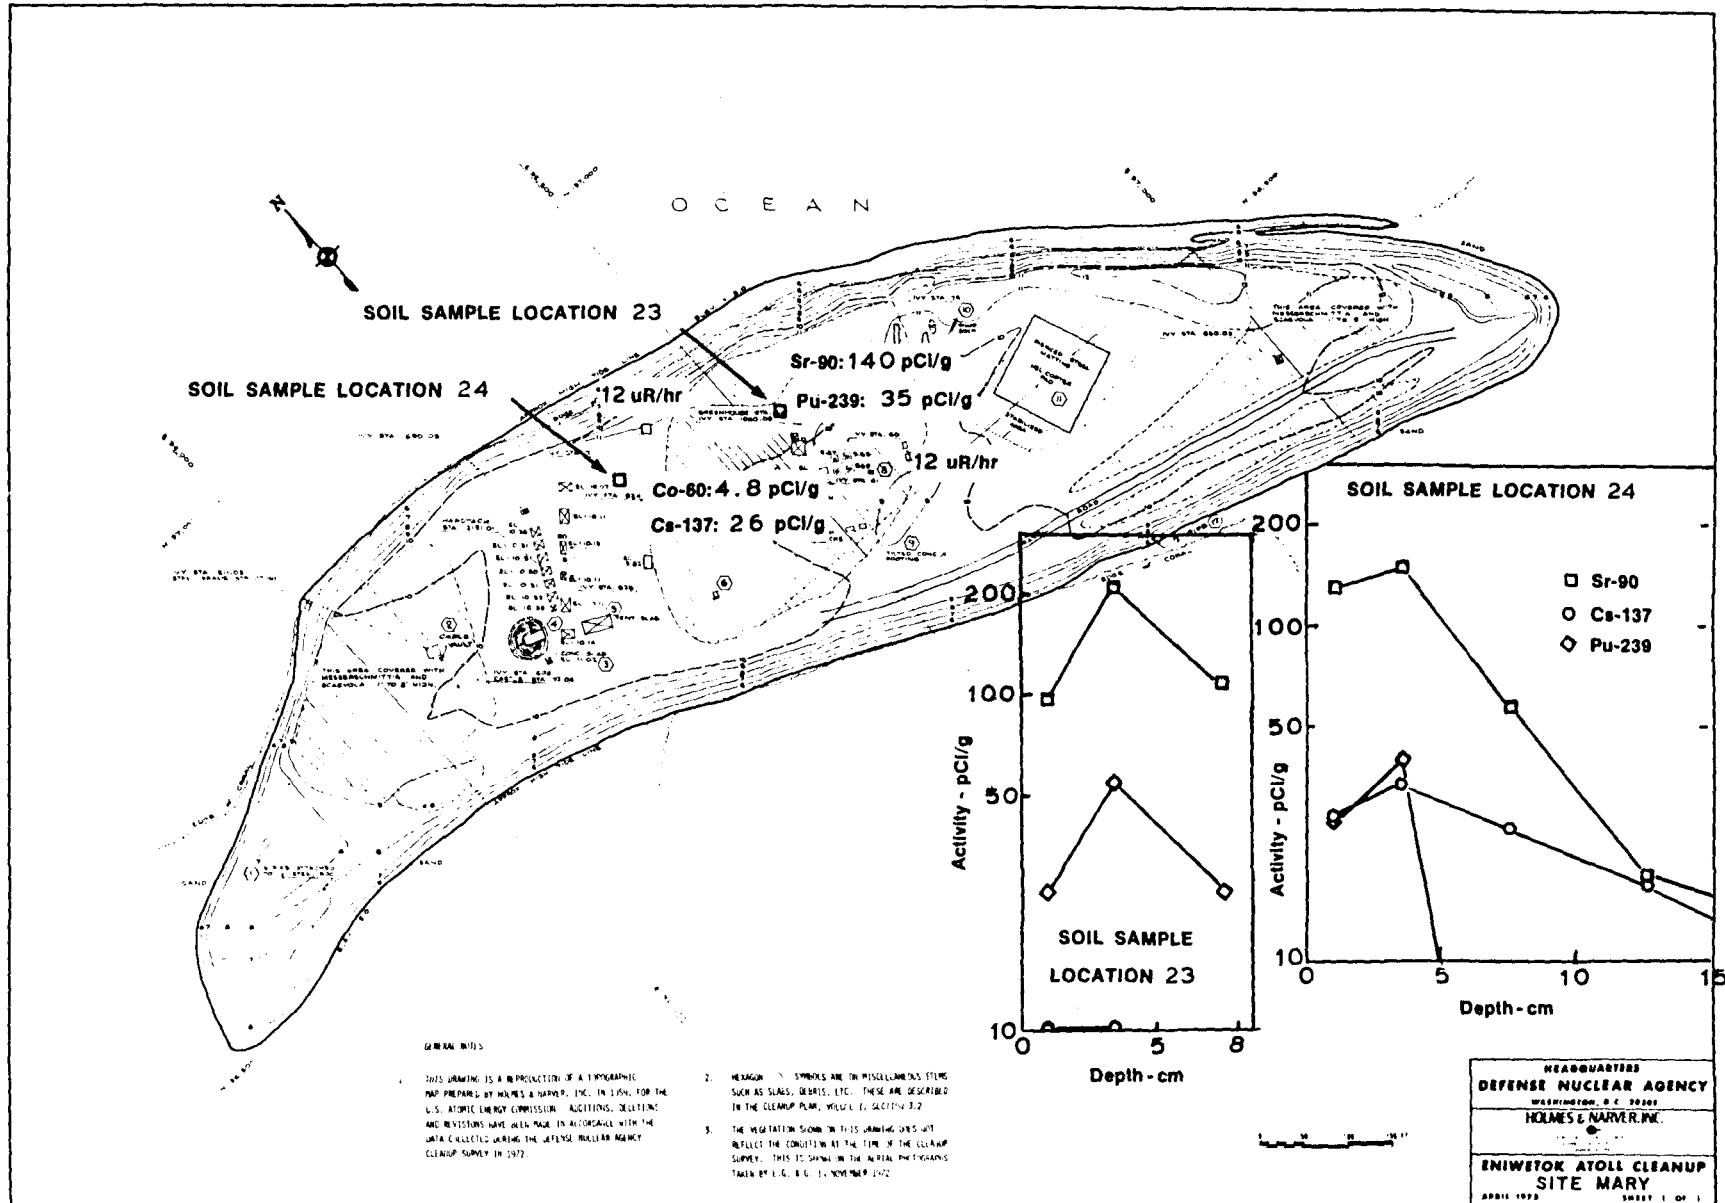
FIGURE 37. SITE MAP

MARY was used for instrumentation during OPERATIONS GREENHOUSE, IVY and HARDTACK (Figure 37). Structures of poor condition remain from those operations. MARY has no surface zeroes but ranks 12th of all islands in the Atoll with 2,785 R/h accumulated H+1 hour exposure rate.

No radioactive material burials are known to exist on MARY.
